Purpose: CERCLA Site Inspection

Site: Buckeye Properties
1296 Armstrong Ave.
San Francisco, CA

Date of Inspection: February 3, 1993

Report Date: June 14, 1993

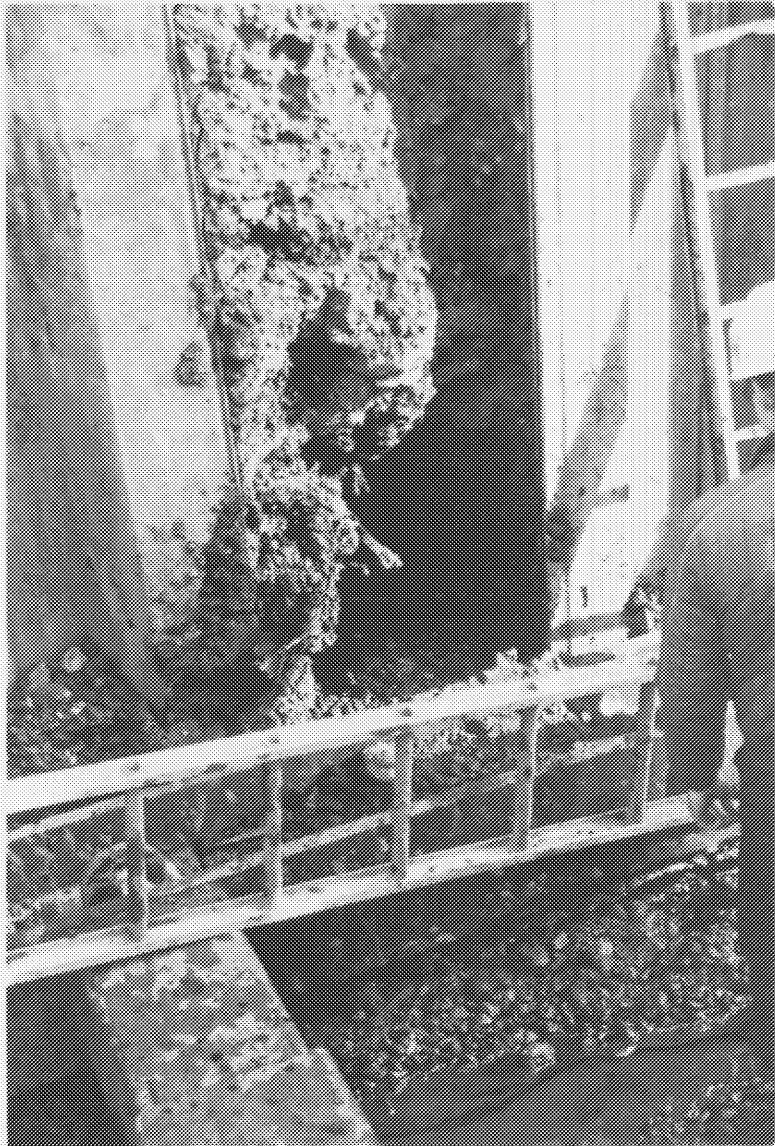
DESCRIPTION- According to Mr. Ricci, this photograph shows the excavation for the 1986-1987 City of San Francisco sewer consolidation project. Visible staining appears to be limited to the subsurface soils.

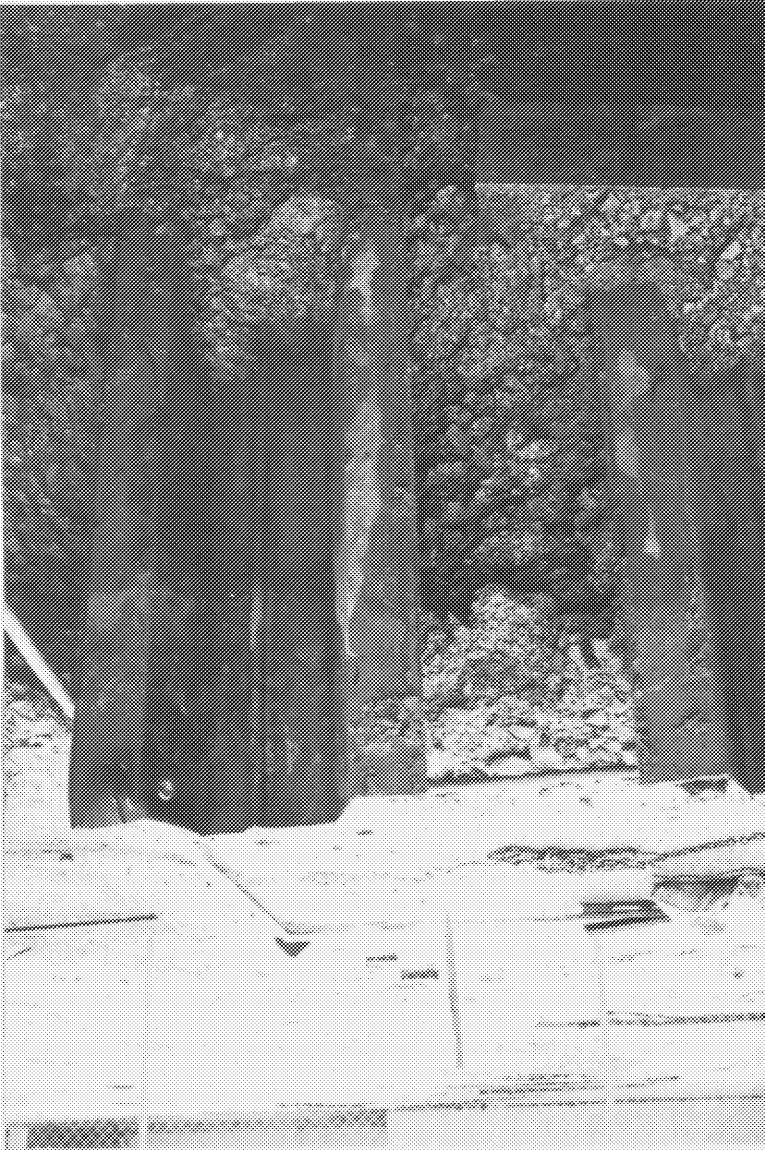
DESCRIPTION: According to Mr. Riccl, this photograph shows the excavation for the 1986-1987 City of San Francisco sewer consolidation project. Visible staining appears to be limited to the subsurface soils.

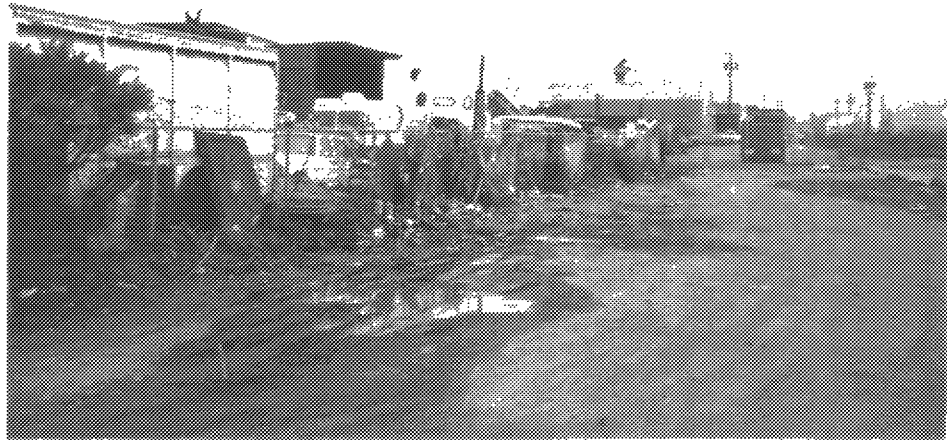
DESCRIPTION: View northwest along Yosemite Ave. Buckeye Properties on left. Note disabled vehicles, debris, fence, and warehouses.

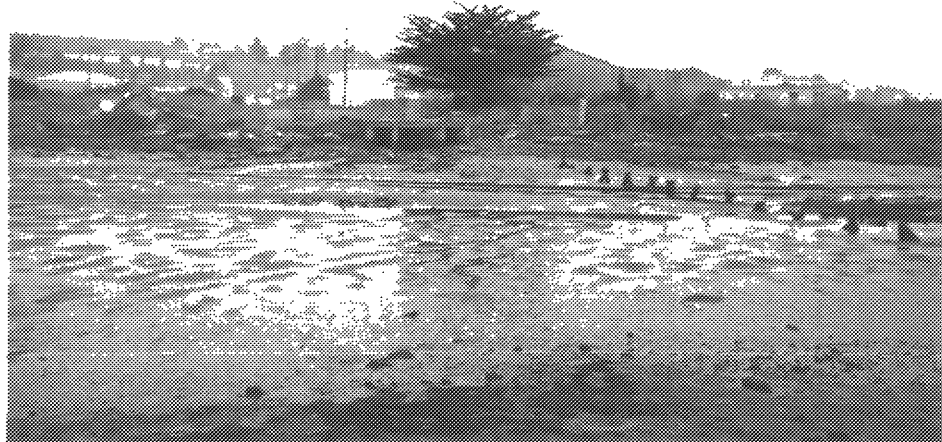
DESCRIPTION: View from Yosemite Ave. at Griffith St., northeast across South Basin Inlet. Note storm sewer outfall.

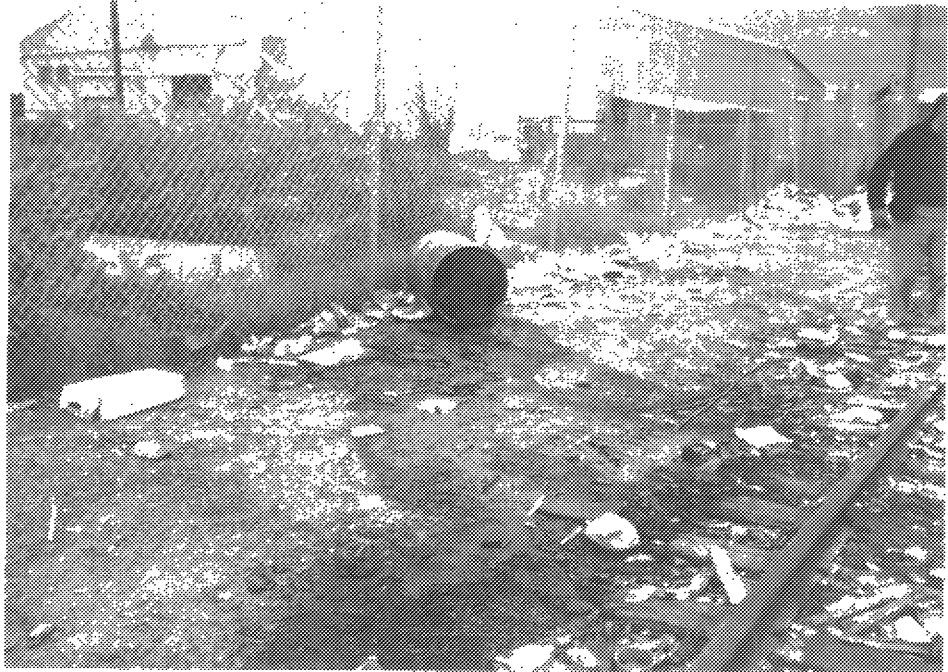
DESCRIPTION: View northeast along old Navy railroad right-of-way. Note spilled drum, and miscellaneous debris. This area is not on Buckeye Properties.

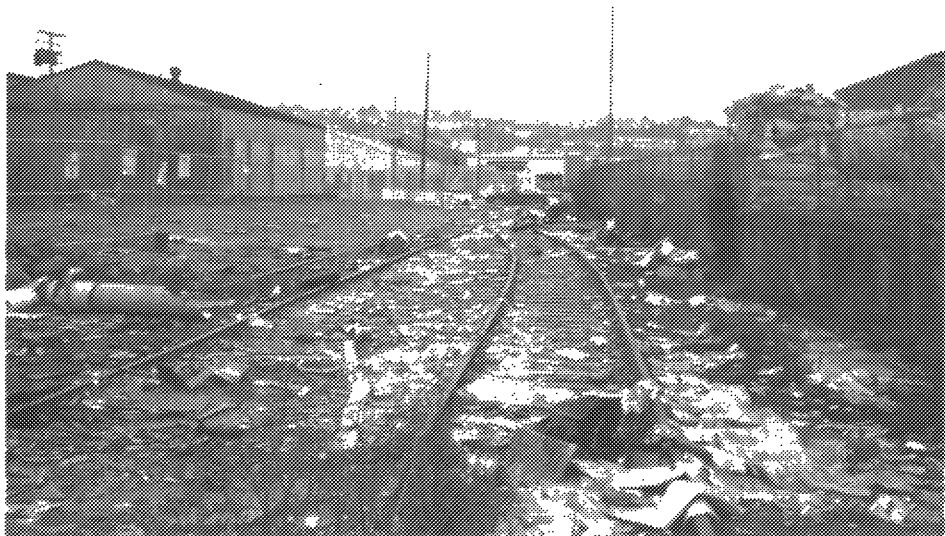
DESCRIPTION: View west along old Navy railroad right-of-way. Note miscellaneous debris. This area is not on Buckeye Properties.
